FLOOD AND BANK EROSION
STUDY
Fort Vermilion, Alberta
March, 1968

March, 1968

Hydrology Branch
Alberta Water Resources Division

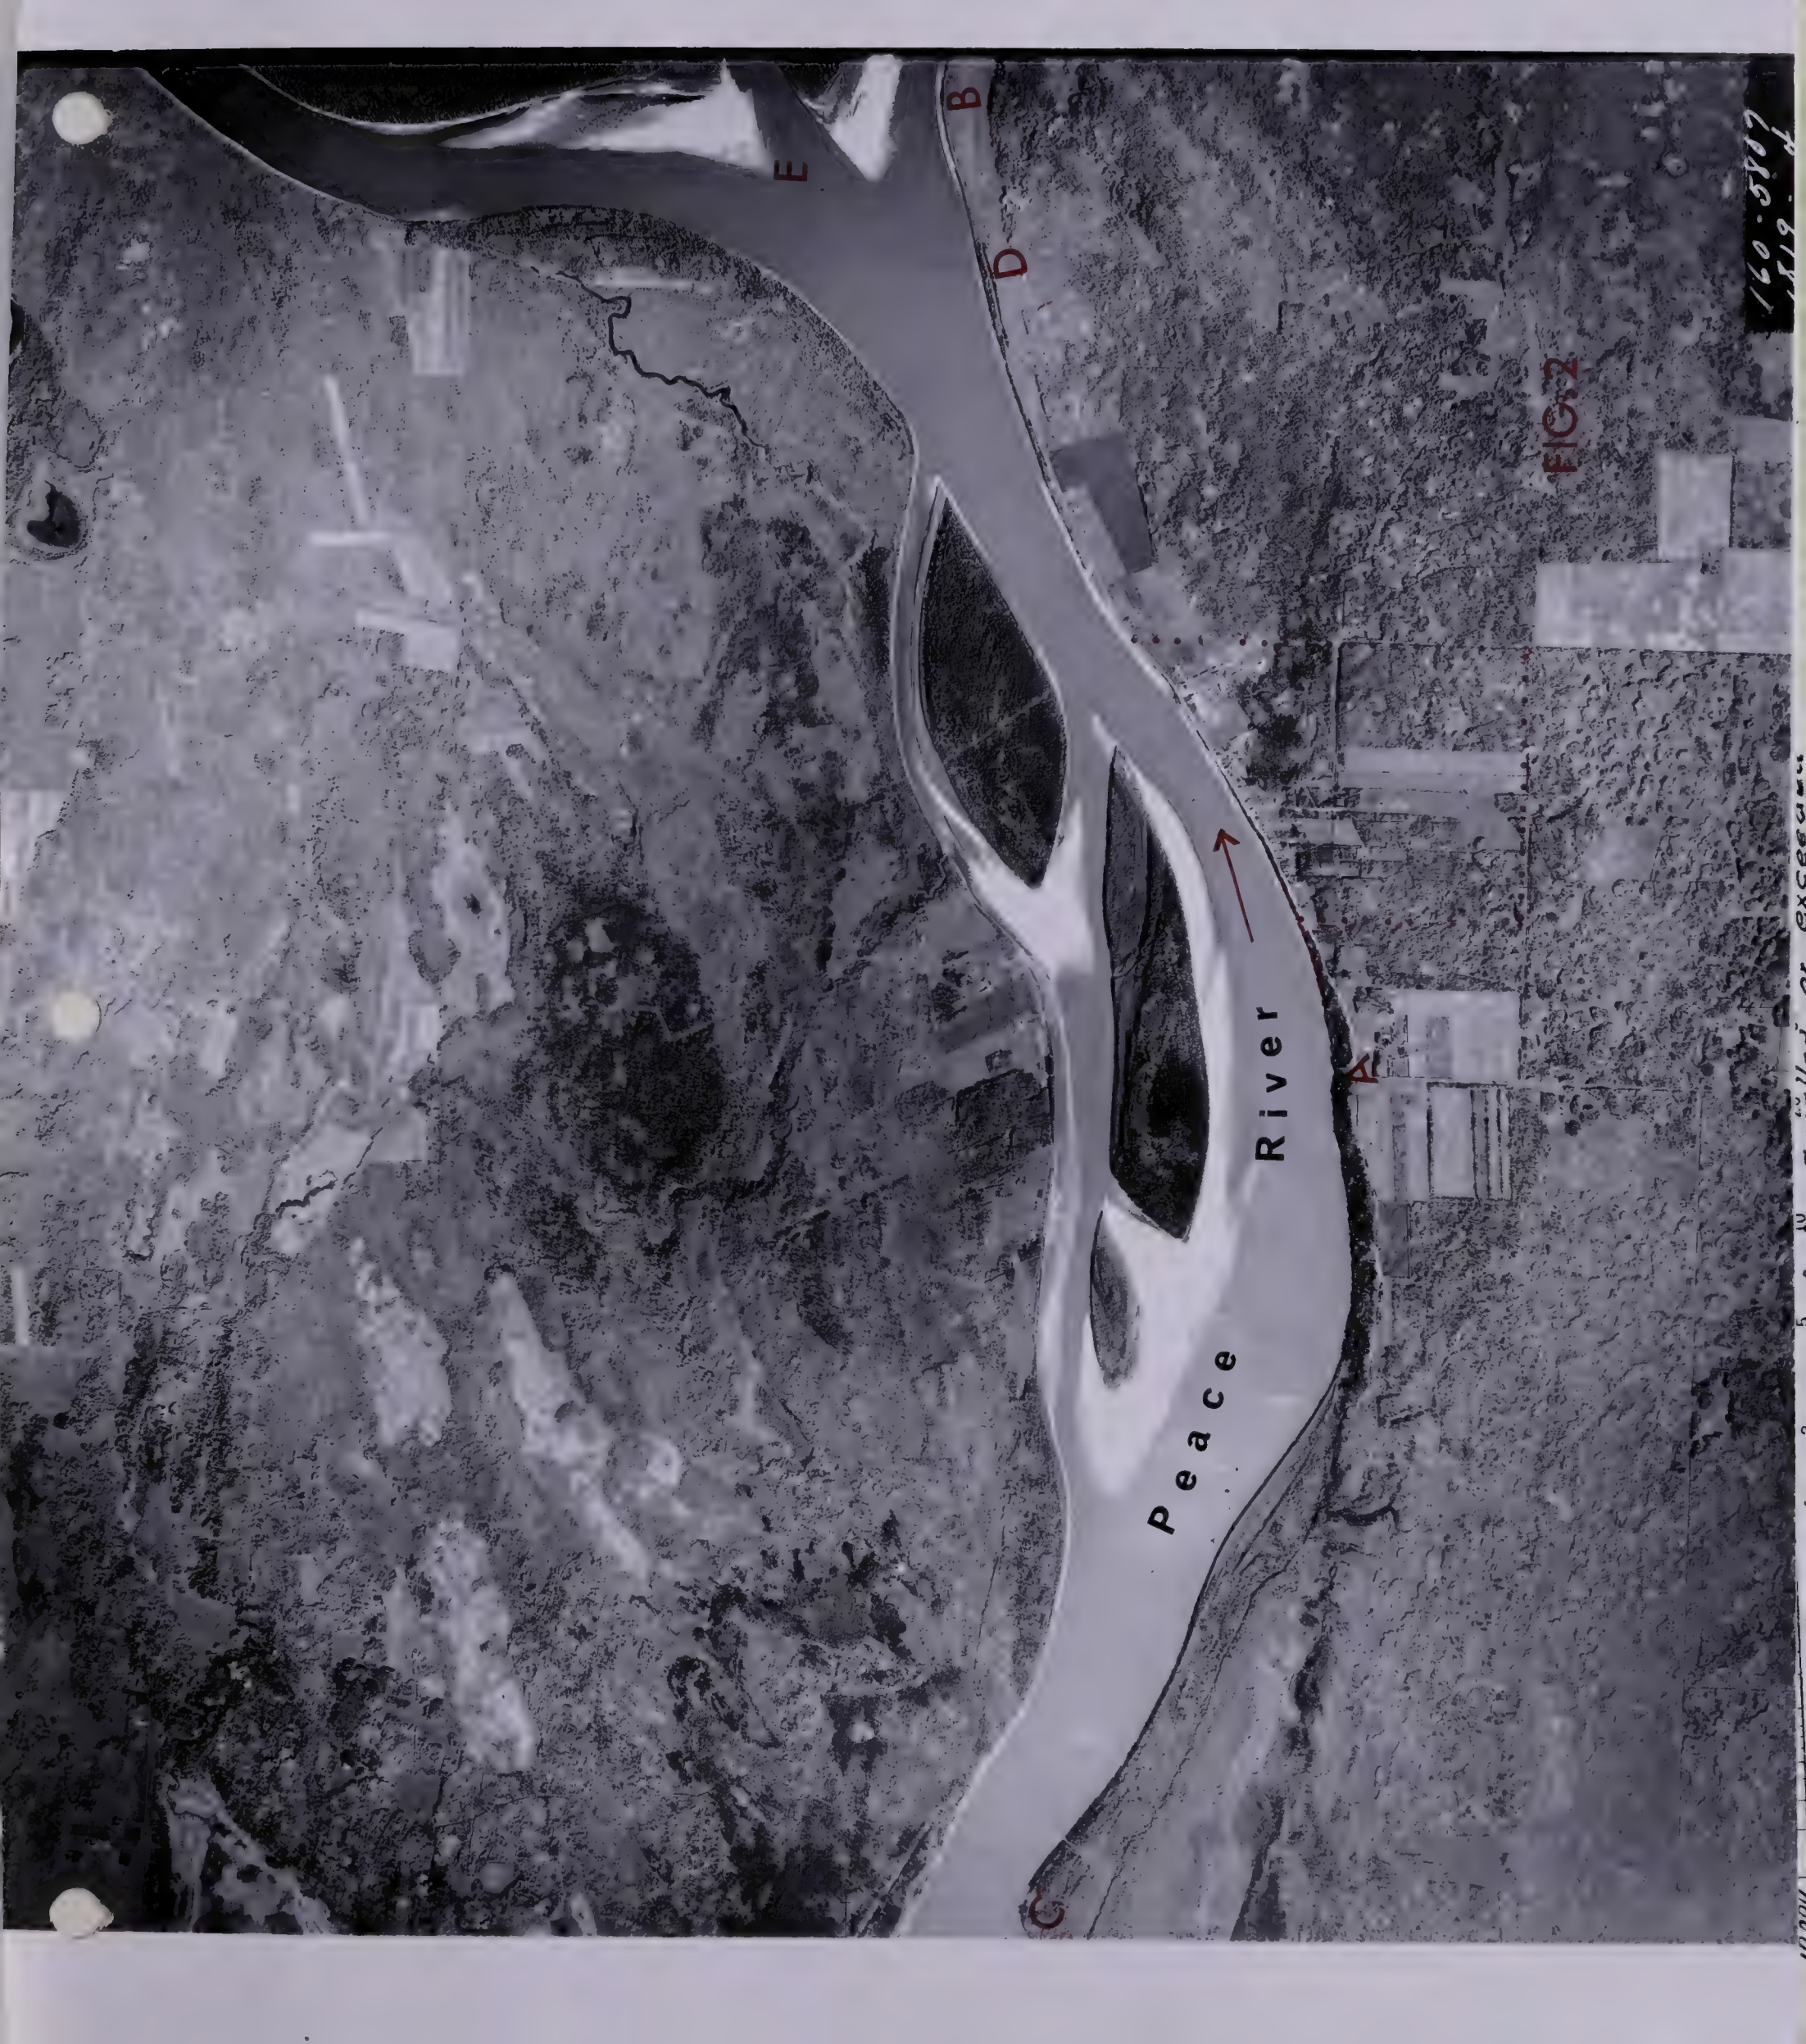
FIG. 2

The area of primary concern to the Department of Municipal Affairs is that area outlined in red (Figure 2). It is in this area that the major amount of residential development has occurred to-date.

2.2 Referring to Figure 2, the Peace River is shown confined to a single 1700 foot channel two miles west of Fort Vermilion. In contrast, the reach adjacent to the settlement shows that the river can operate in two and sometimes three channels. Figure 3 shows the approximate bankfull widths of the river's channels at various sections.

The pattern of flooding in Fort Vermilion can be roughly established. Water would initially top the right bank in the area of point D, (Figure 2), and because land west of this point generally has an upward slope, the land affected would tend to move westward as the flood elevation continued to rise above 830. This point is confirmed somewhat as during the 1934 flood, water was described as being six feet deep at the airport and only a foot or so, two miles west in the densely settled area of Fort Vermilion.

It is believed that ice jamming originates in that reach of river north of the airport (point E, Figure 2). Here the river channel expands considerably, and this would have the effect of reducing the velocity of flow. This decrease in velocity, coupled with sudden changes in direction of flow, would cause the ice to move sluggishly and possibly pile up in the area of point E (Figure 2). Serious ice jamming would occur under certain undefined climatic and hydraulic conditions.

7.5 Construction of dyke: Since flooding problems probably begin at point D (Figure 2), it might prove feasible to construct a dyke along the right bank between stations 90+00 and 150+00. This dyke would have a crest elevation of about 840 (Geodetic). It is not possible to confidently assign a design return period to this elevation because as mentioned above, it is the high water caused by unpredictable ice jams that is being designed for.

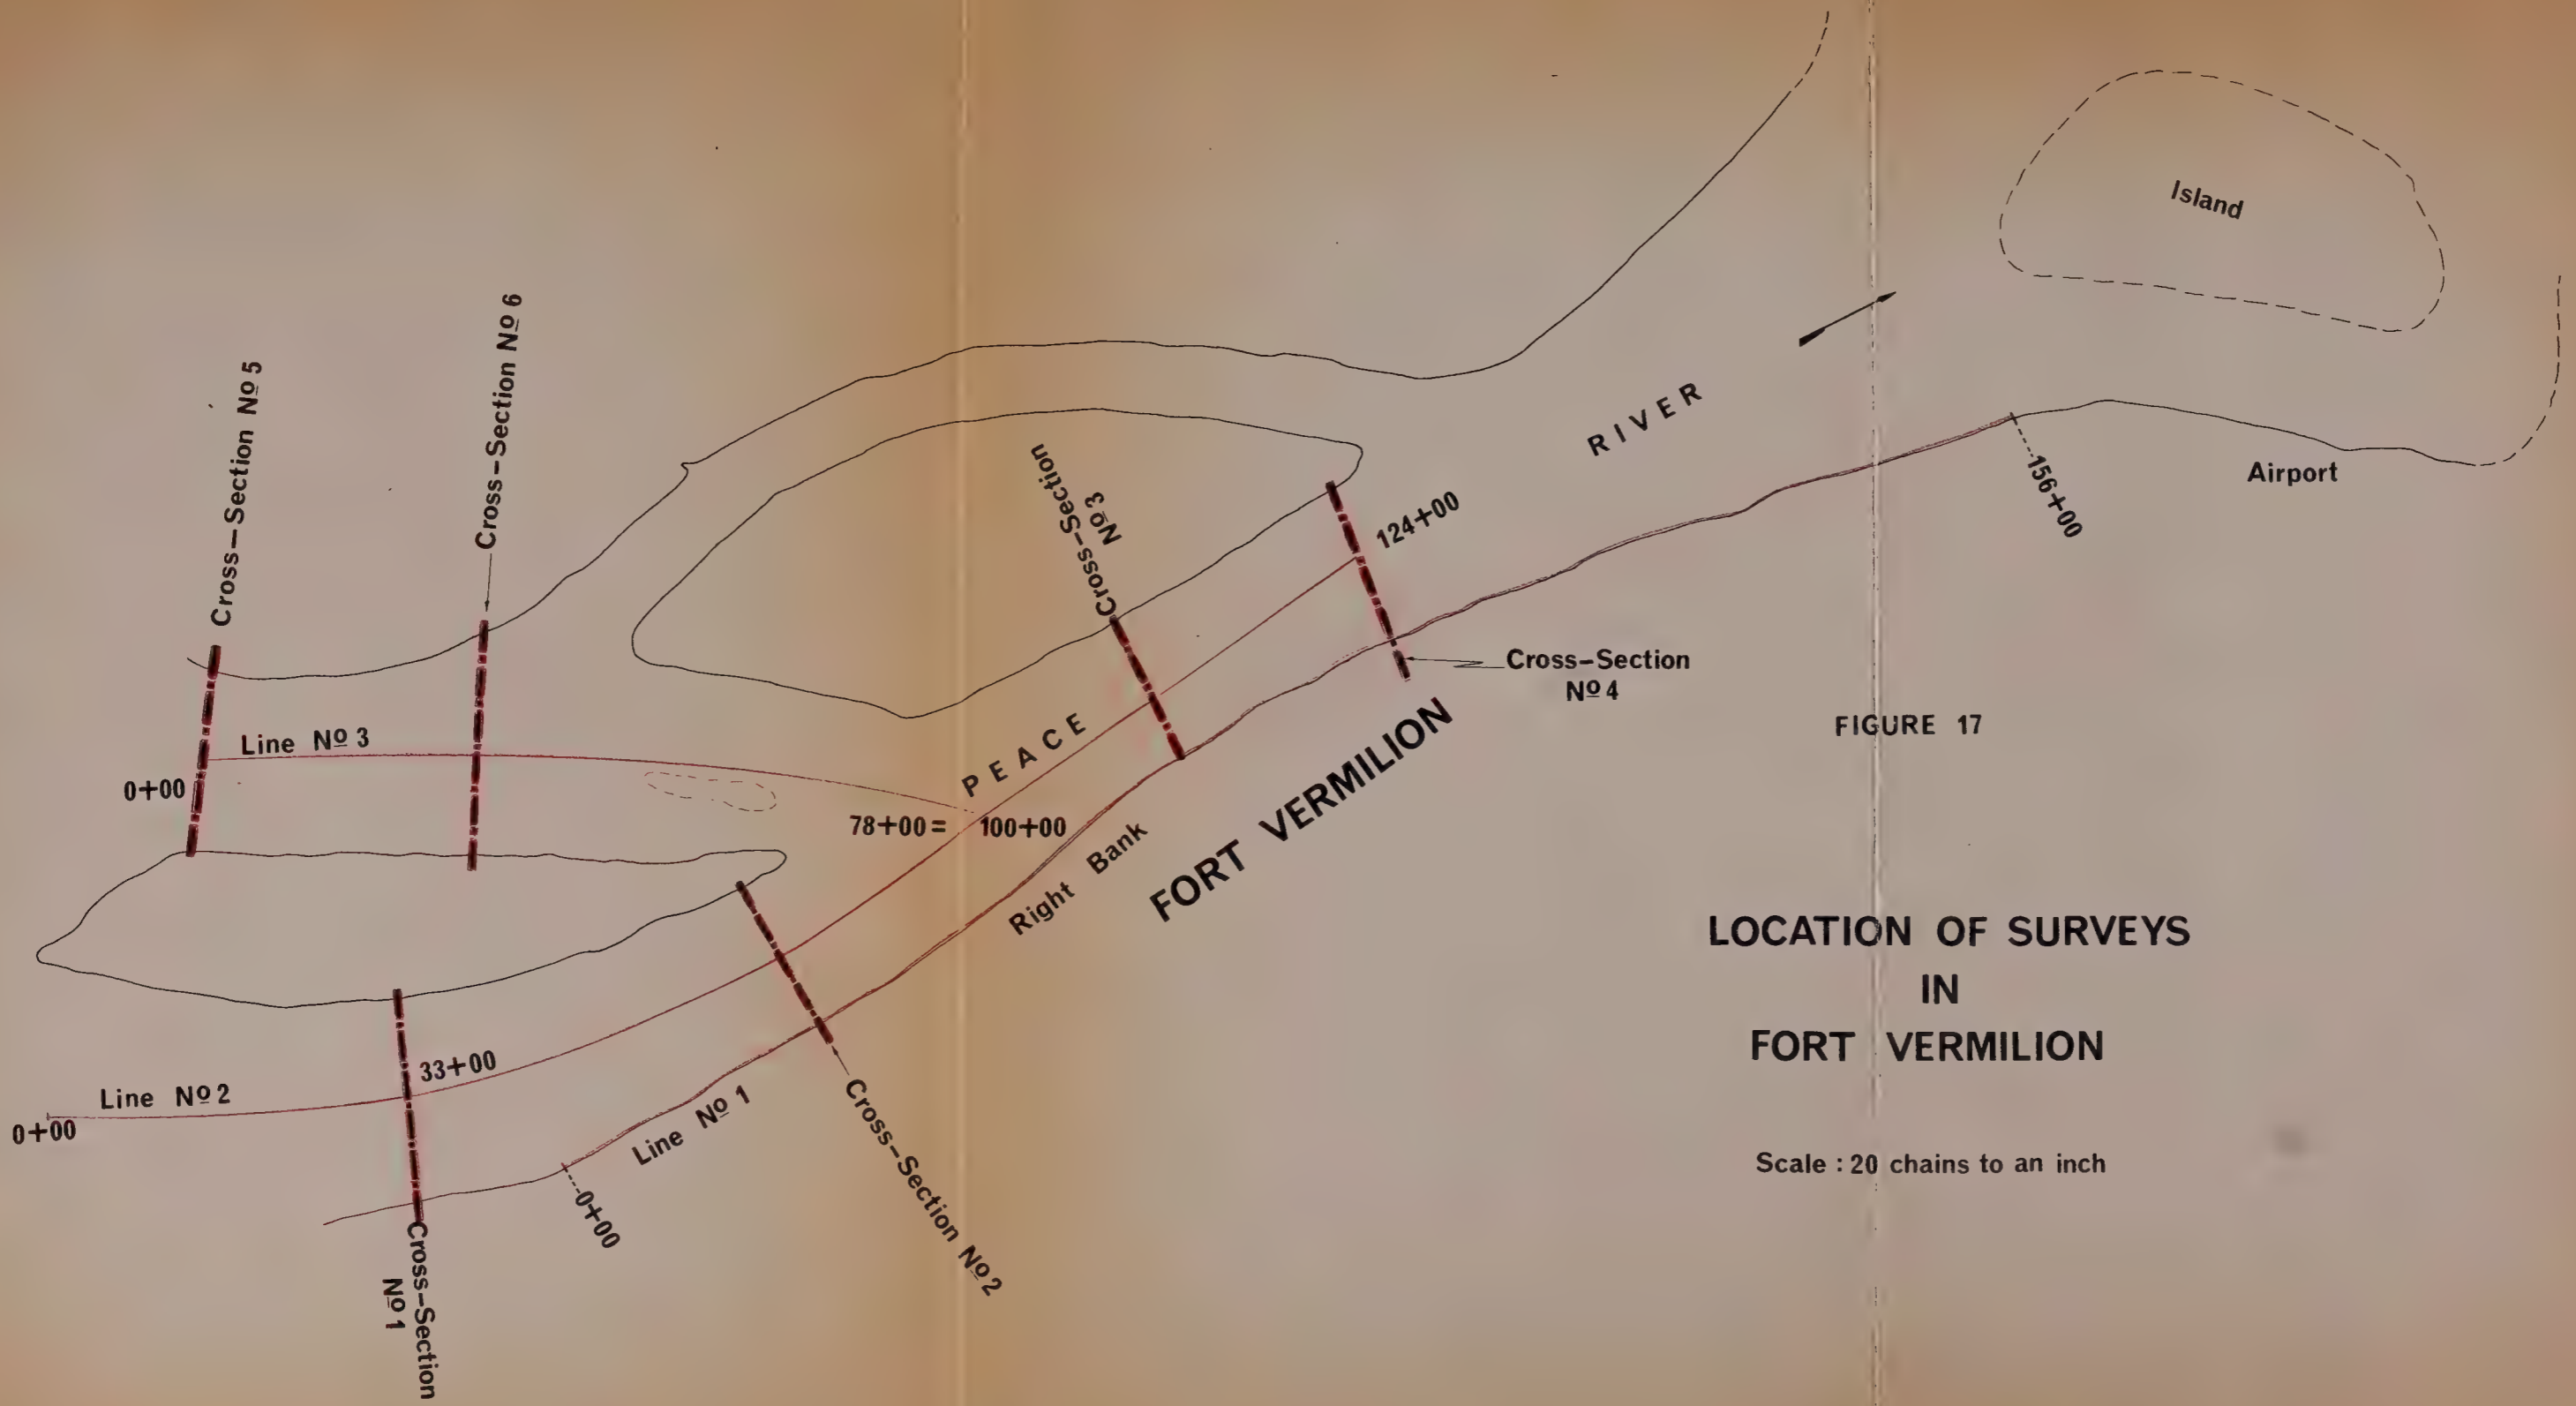
FIGURE 17

5.1 Surveys were carried out in order to obtain some physical measure of the Peace River channel adjacent to the Fort Vermilion settlement. Figure 17 outlines the various lines surveyed where; line 1 is a profile survey of the top of the right bank, line 2 is an ice surface and bed profile survey of the main channel, and line 3 is an ice surface and bed profile survey of the secondary channel. In addition, the red lines indicate the approximate location of sections which were surveyed.

**LOCATION OF SURVEYS
IN
FORT VERMILION**

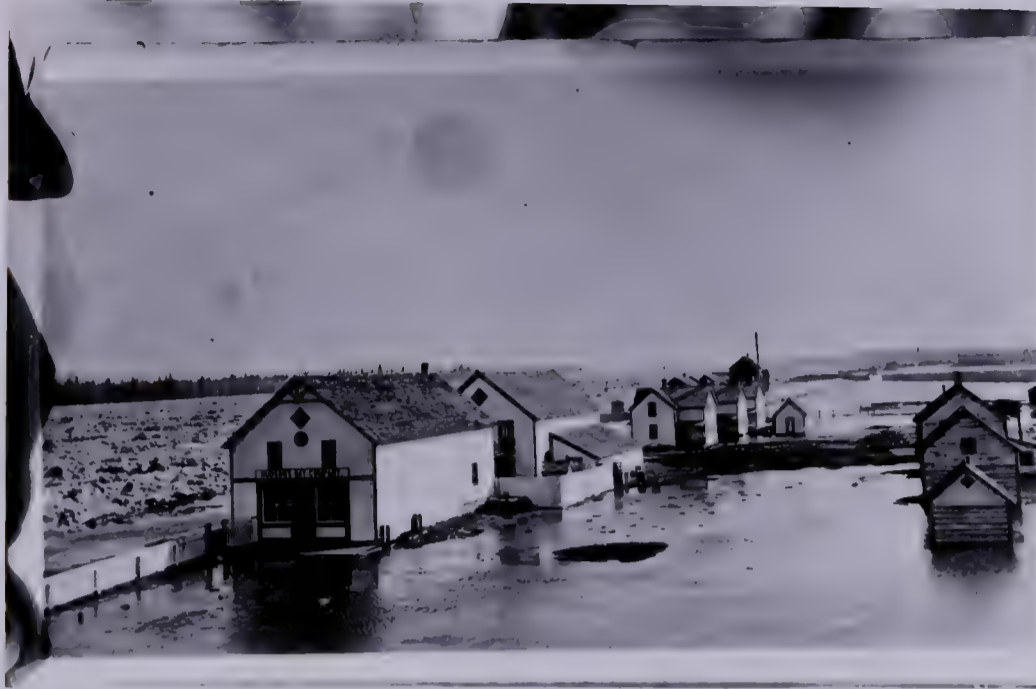
PHOTO 1

The first photograph shows the flood waters in the flood plain adjacent to the right bank, and in the background, the jamming of ice can be noted. As closely as could be determined this photograph was taken looking downstream from point D, Figure 16.

1934 FLOOD IN FORT VERMILION

VIEW OF HUDSONS BAY COMPANY BUILDINGS PROBABLY
VIEWED FROM POINT D, FIGURE 16.

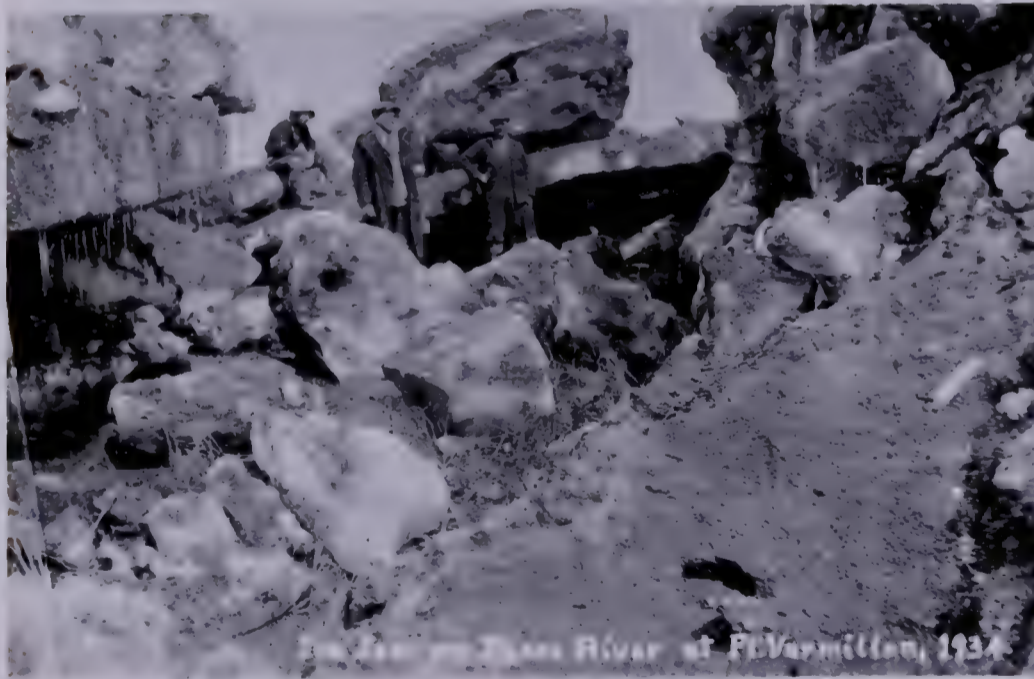
PHOTO 2

The second photograph indicates what tremendous forces must be at work during ice jams. This photograph was taken about one-half mile upstream of the first one, or at about point E, Figure 16.

THIS PHOTO PROVIDES A GOOD IDEA OF THE SIZE OF FORCES
AT WORK DURING AN ICE JAM

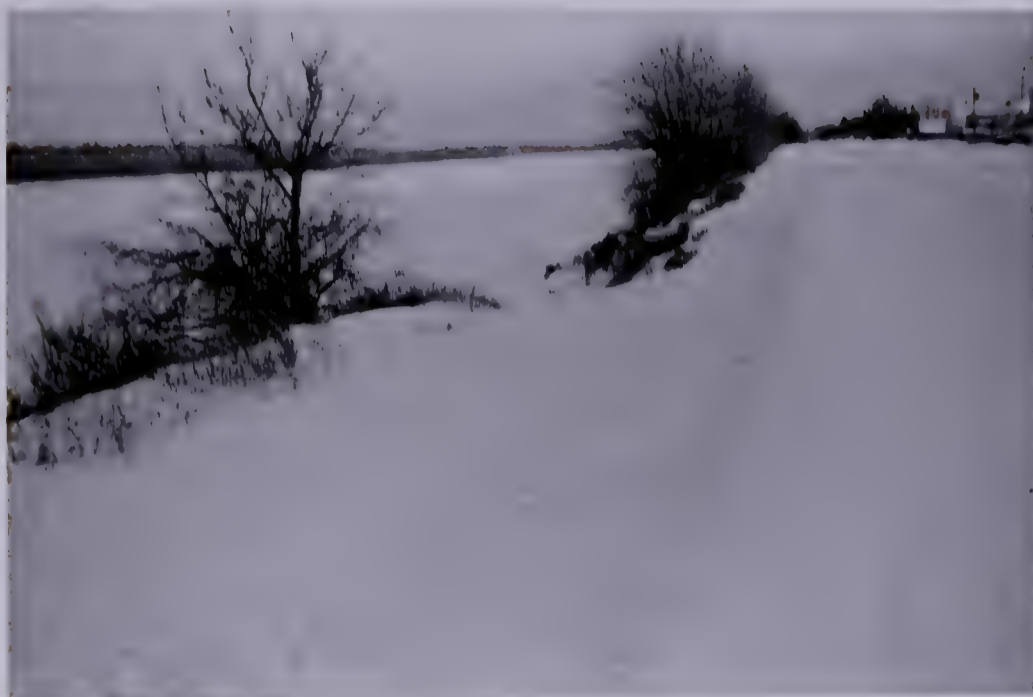
PHOTO 3

RIGHT BANK IN FRONT OF HUDSONS BAY COMPANY STORE
THIS LENGTH OF BANK HAS ERODED ABOUT 21 FEET SINCE 1906

1. From a post on the north-west corner of H.B.C. property (near point D, Figure 16) to bank, was measured as 100 feet. Original measurements had this distance measured as about 100 feet, so apparently little bank erosion has occurred here.
2. From a post to bank-edge at the north-east corner of Hudsons Bay Co. store (near point H, Figure 16) was measured as 59 feet. Original measurements had this distance measured as 80 feet which indicates that about 21 feet of bank has eroded since 1906.

8.2 It appears that the main area where active bank erosion is occurring is in front of the Hudsons Bay Company store. Photographs show that the length of this eroding reach is about three hundred feet long.

This bank erosion will continue at its slow rate of about one-third of a foot per year and if it is proposed to construct a main road adjacent to this reach, then some form of bank protection should be considered. In the remainder of that length of right bank from point A to B, Figure 2, some small amount of erosion is taking place but at a very slow rate. Test holes taken in a survey in 1967 indicate that shale may be outcropping along the right bank, and its presence would partly explain the slow rate at which the right bank is eroding.

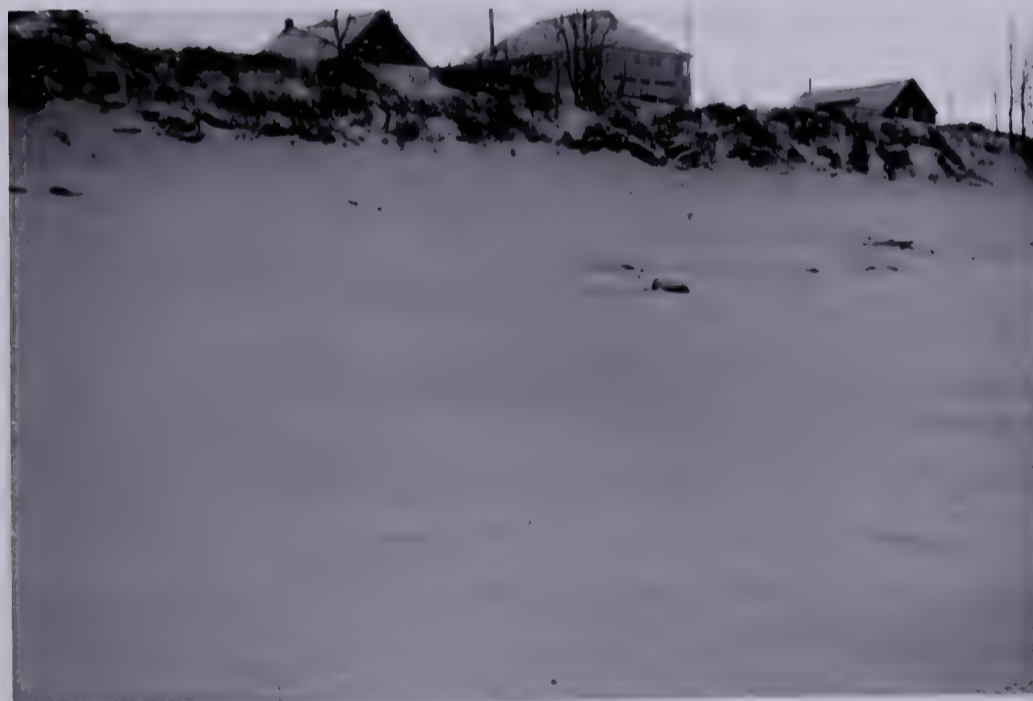
PHOTO 4

SAME LENGTH OF BANK AS ABOVE VIEWED FROM RIVER.
HUDSONS BAY STORE IN BACKGROUND
NOTE SPARSE TREE GROWTH

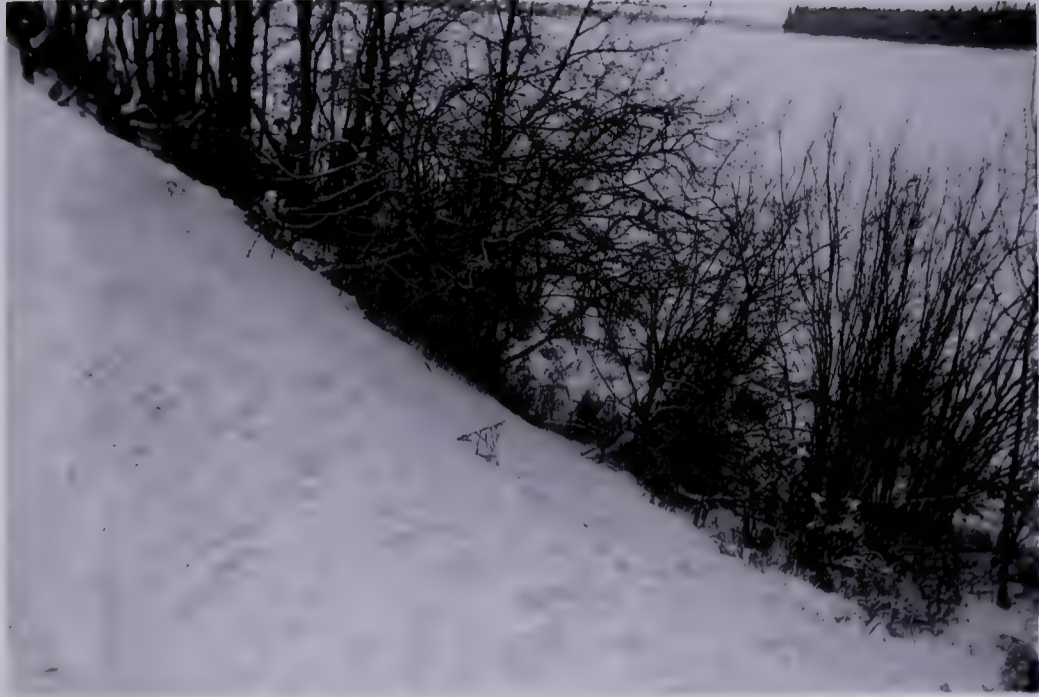
PHOTO 5

LOOKING UPSTREAM ON THE PEACE RIVER AT FORT VERMILION
NOTE TYPE OF VEGETATION ON RIGHT BANK

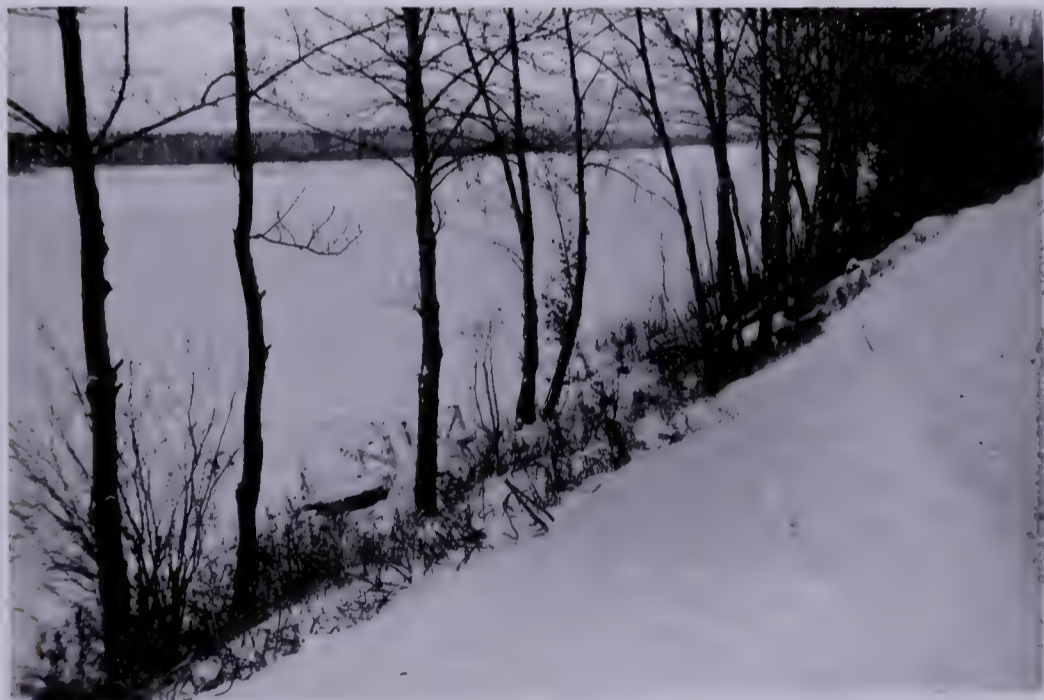
PHOTO 6

LOOKING DOWNSTREAM ON THE PEACE RIVER AT FORT
VERMILION
NOTE SPARSE TREE GROWTH ON RIGHT BANK

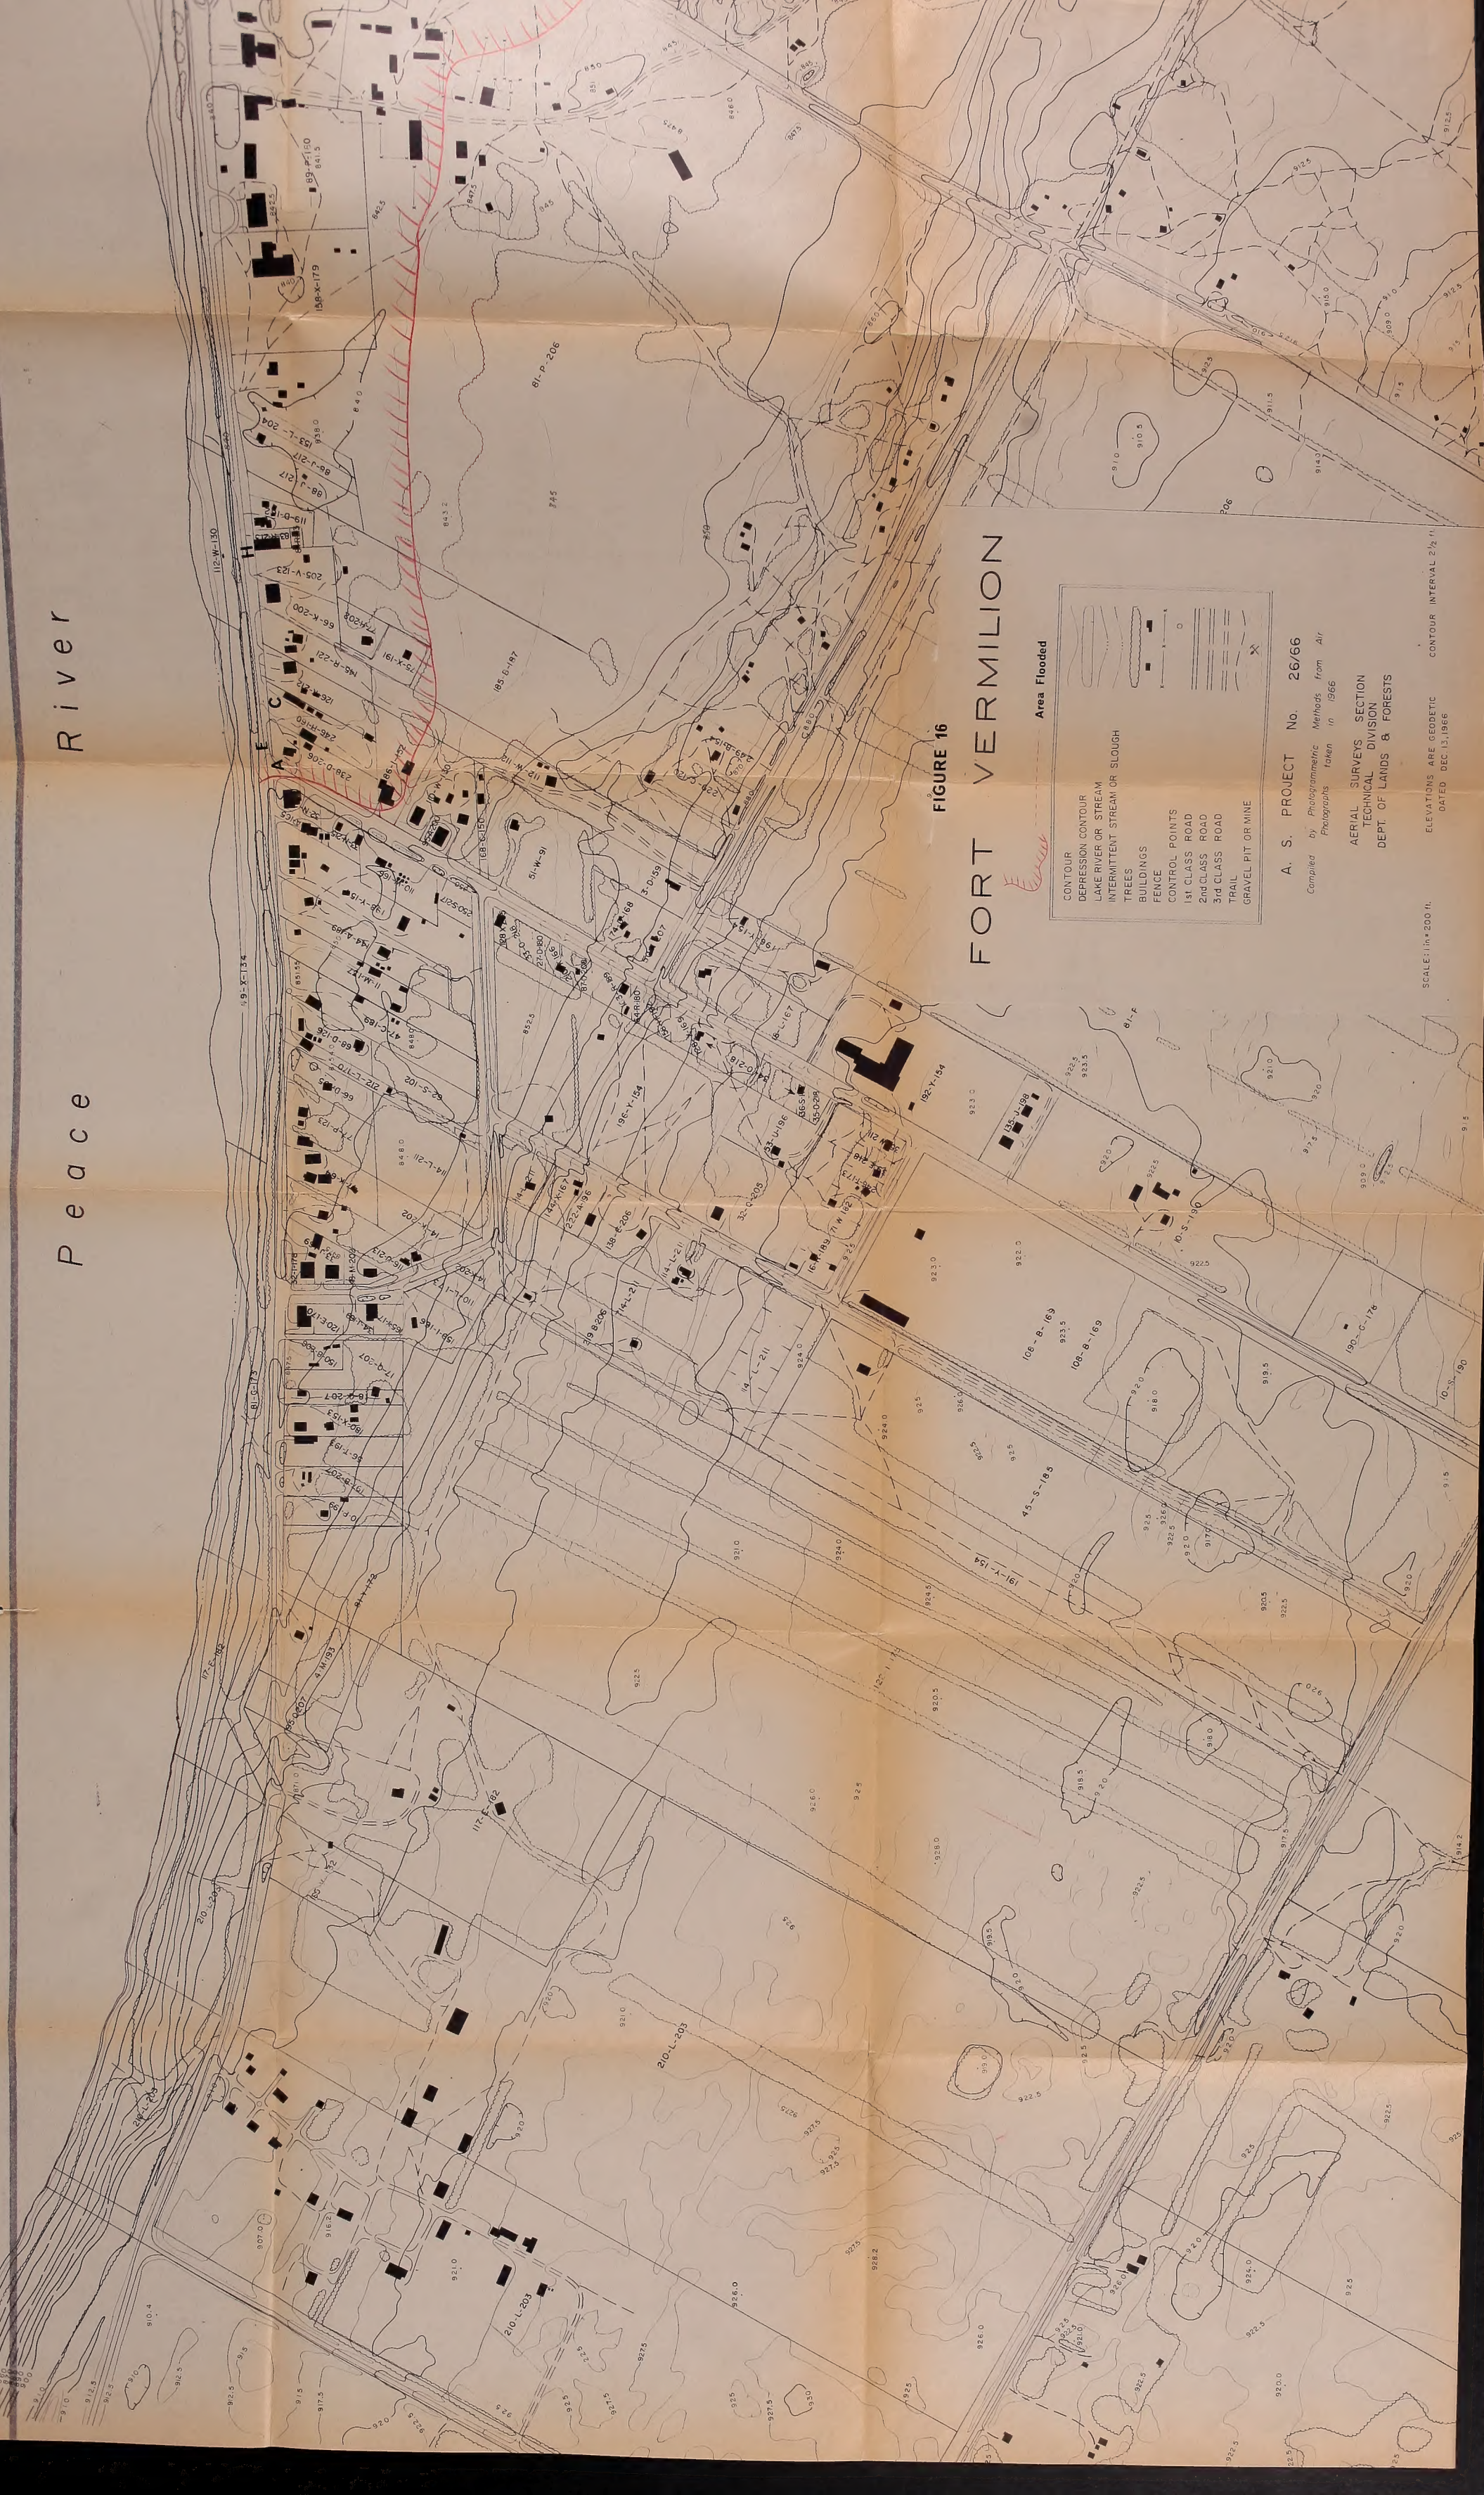
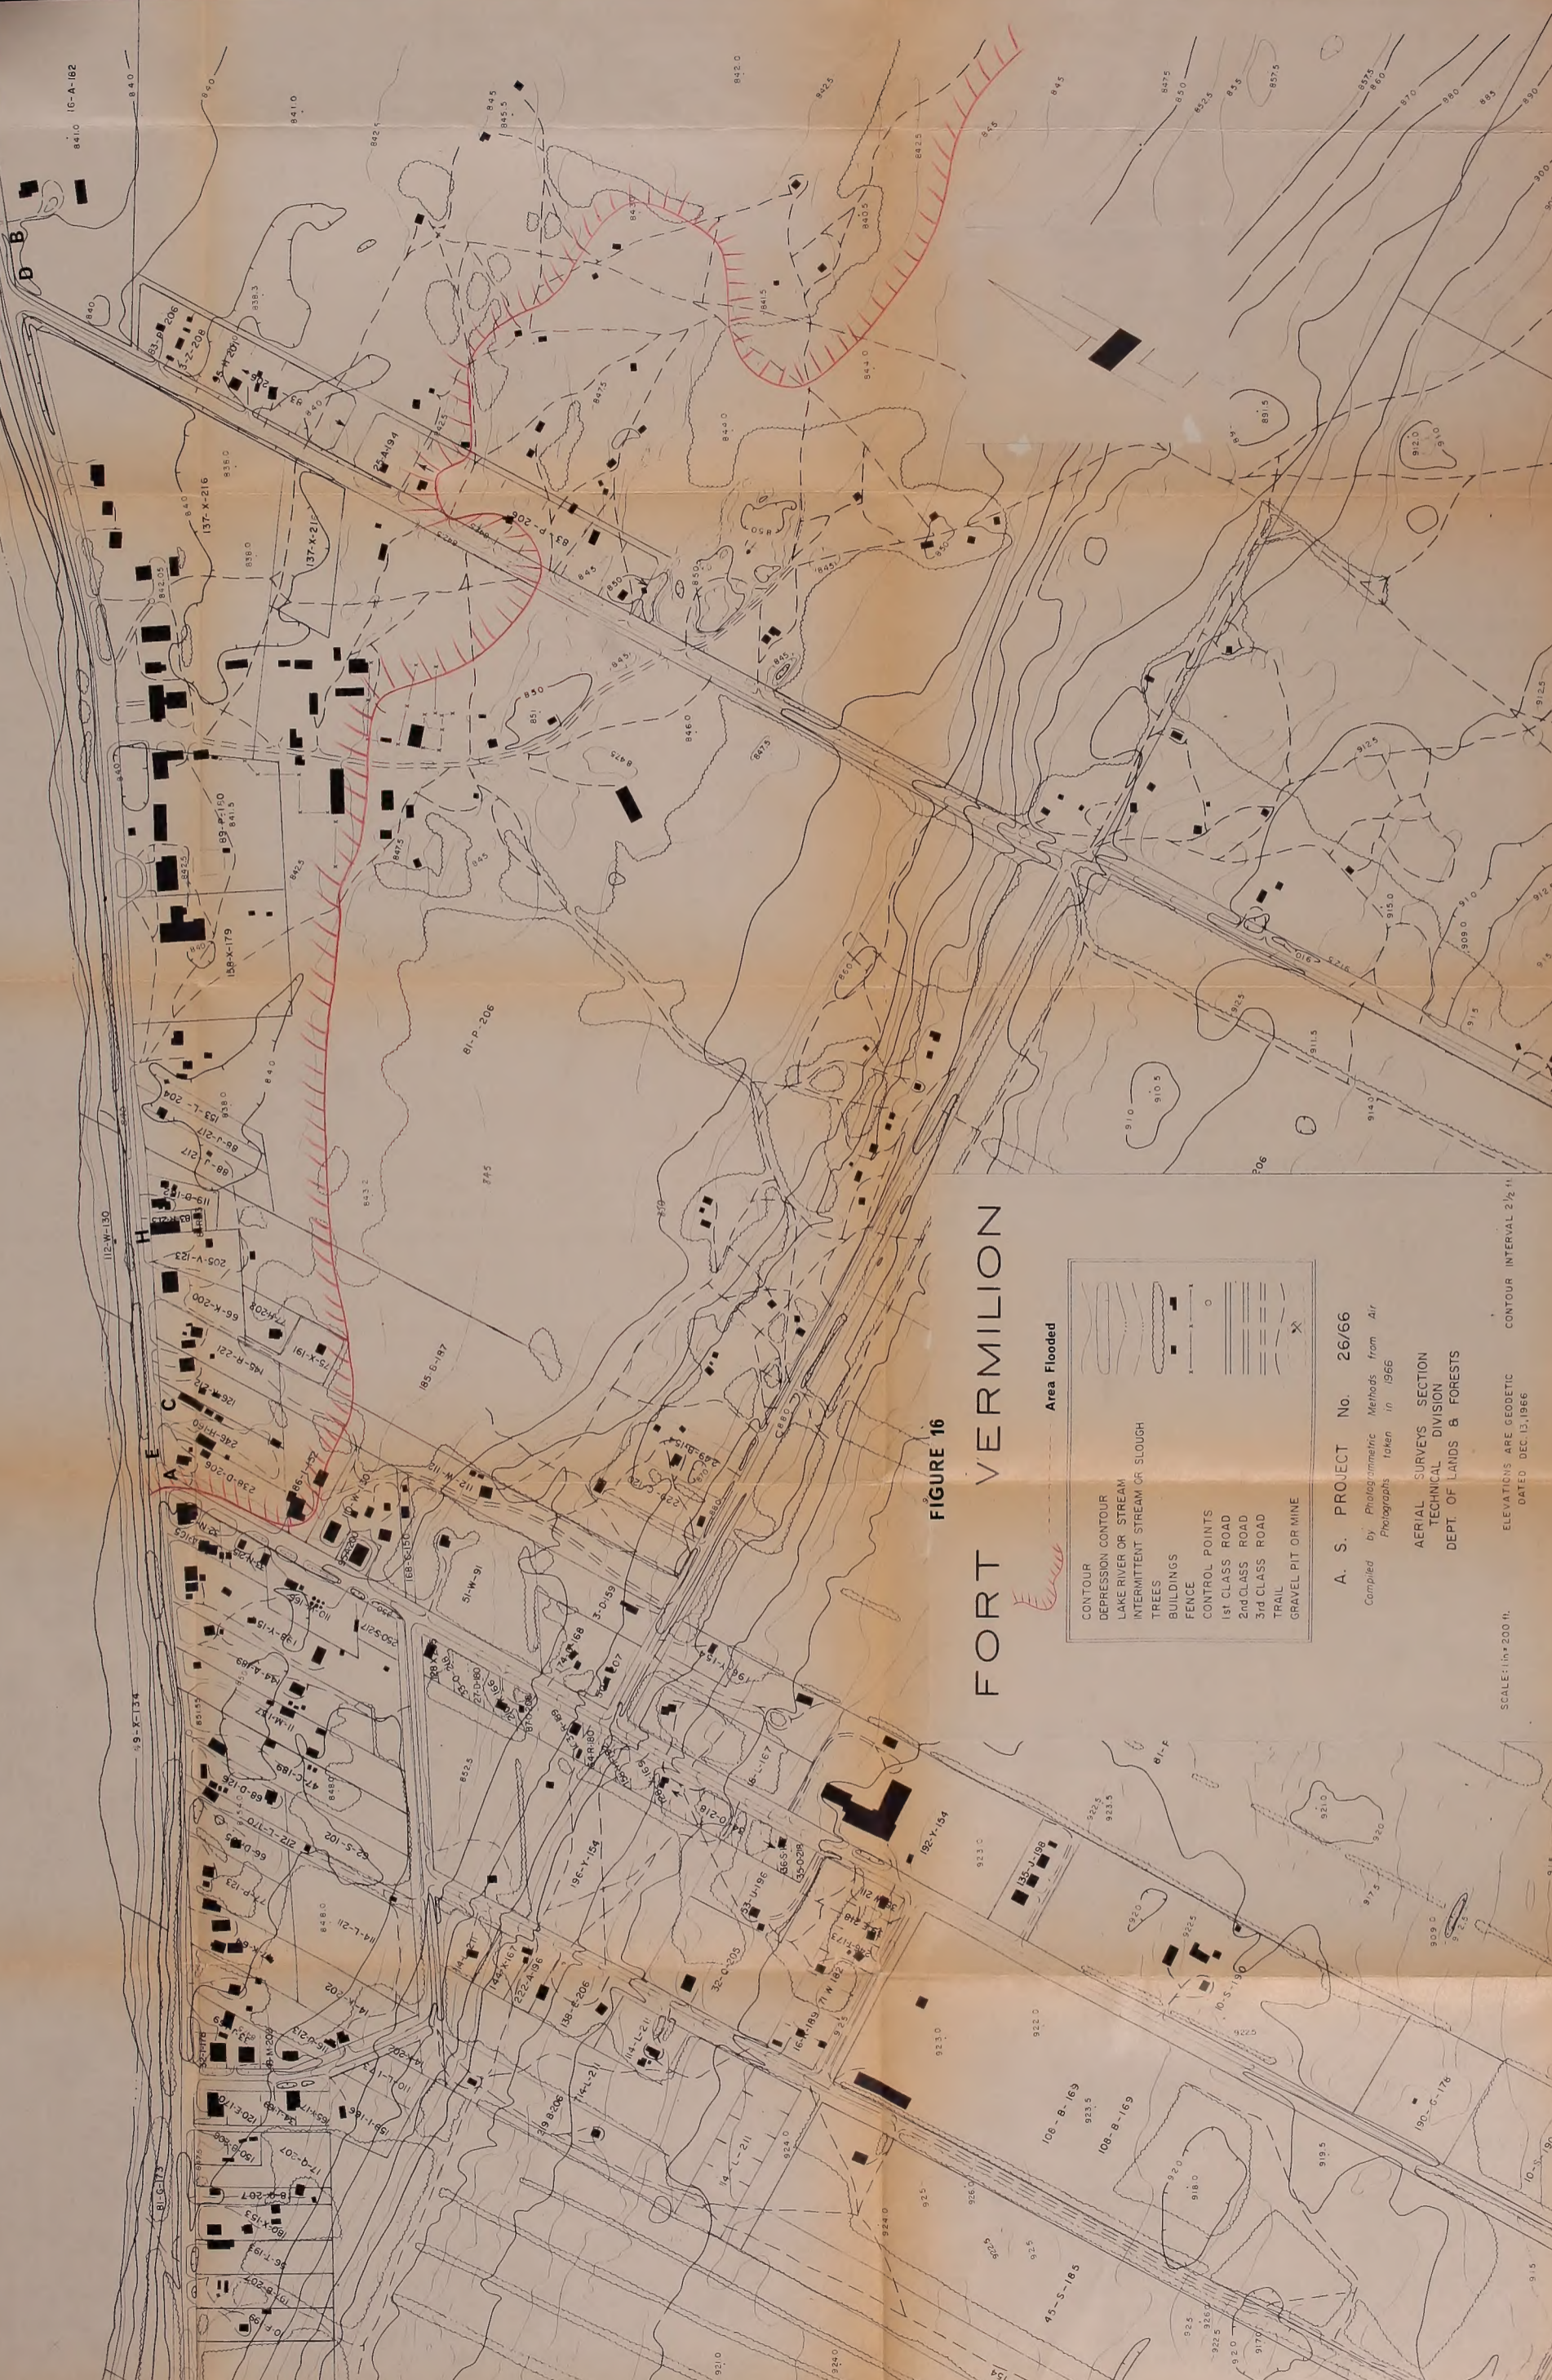
FIGURE 16
FORT VERMILION

Probable extent of the 1934 flood is outlined in red on Figure 16. As the first photograph on page C1 shows, the area east of that shown in Figure 16, was also under water at this time.

- 9.3 The 1934 flood is the worst in memory and its probable extent of flooding in the area shown by Figure 16, is shown there bounded by a red line. It is impossible to assign a probability of recurrence of this flood.

Area Flooded

It is estimated that there was one foot of water at the theatre corner, and two feet at the Hudson Bay Co. store, points A and B respectively, Figure 16.

Water reached the base of the B and B Motel restaurant (point C, Figure 16), in the 1934 flood.

- 9.2 The land between the airport and the east edge of the area shown on Figure 16 is more liable to flooding action because of its generally lower position in the flood plain.
